NBS BUILDING SCIENCE SERIES 143

Investigation of the Kansas City Hyatt Regency Walkways Collapse

DEPARTMENT OF COMMERCE • NATIONAL BUREAU OF STANDARDS

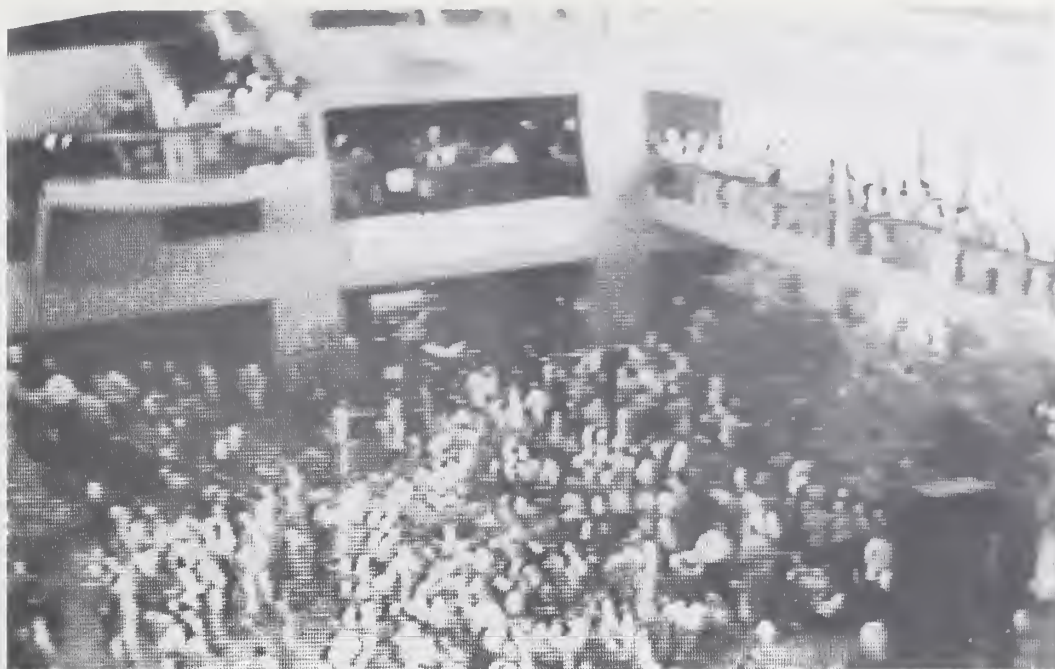
Three segments of the tape provided by KMBC TV were suitable for analysis. The scene in figure 4.4 is from the third floor balcony on the north side of the atrium with the view to the southwest. All of span L7-8 and most of span L8-9 of the second floor walkway are visible. A portion of the third floor walkway is visible at the upper right. The time bracket is believed to be 6:50 to 7:00 PM, based on the scheduled break of the band and their absence from the bandstand which is located directly below the banner on the south wall of the atrium. There appear to be 11 people on span L7-8 and 16 people on span L8-9. Of the 11 people on span L7-8, 10 appear to be standing at the handrail. Of the 16 people on span L8-9, 12 appear to be standing at the handrail.

Figure 4.4 Scene from third floor balcony on north side of atrium. View to the southwest showing spans L7-8 and L8-9 of second floor walkway. Videotape courtesy of KMBC TV.

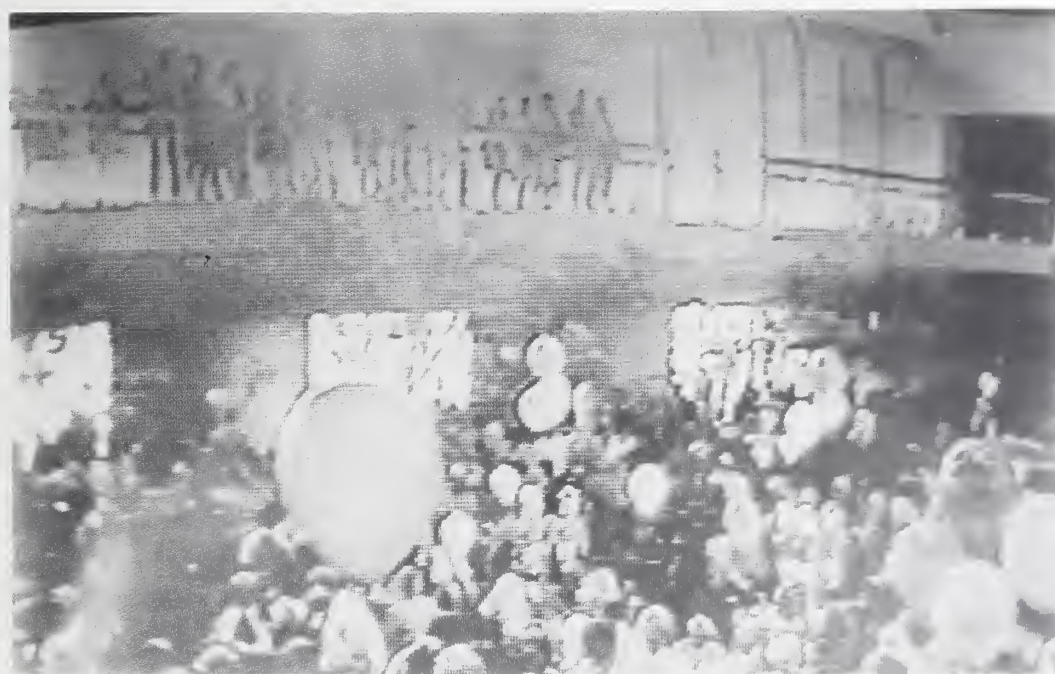
The scene in figure 4.5, believed to have been taken a few minutes after the frame shown in figure 4.4, appears to be from the landing of the main stairway in the southeast corner of the atrium, looking northwest. Part of span L8-9 and all of spans L9-10 and L10-11 of the second floor walkway are visible. Eight or nine people are occupying the south portion of span L9-10 along the handrail and span L10-11 is not occupied.

Figure 4.5 Scene from landing of main stairway in southeast corner of atrium. View to northwest shows part of span L8-9 and all of spans L9-10 and L10-11 of second floor walkway. Videotape courtesy of KMBC TV.

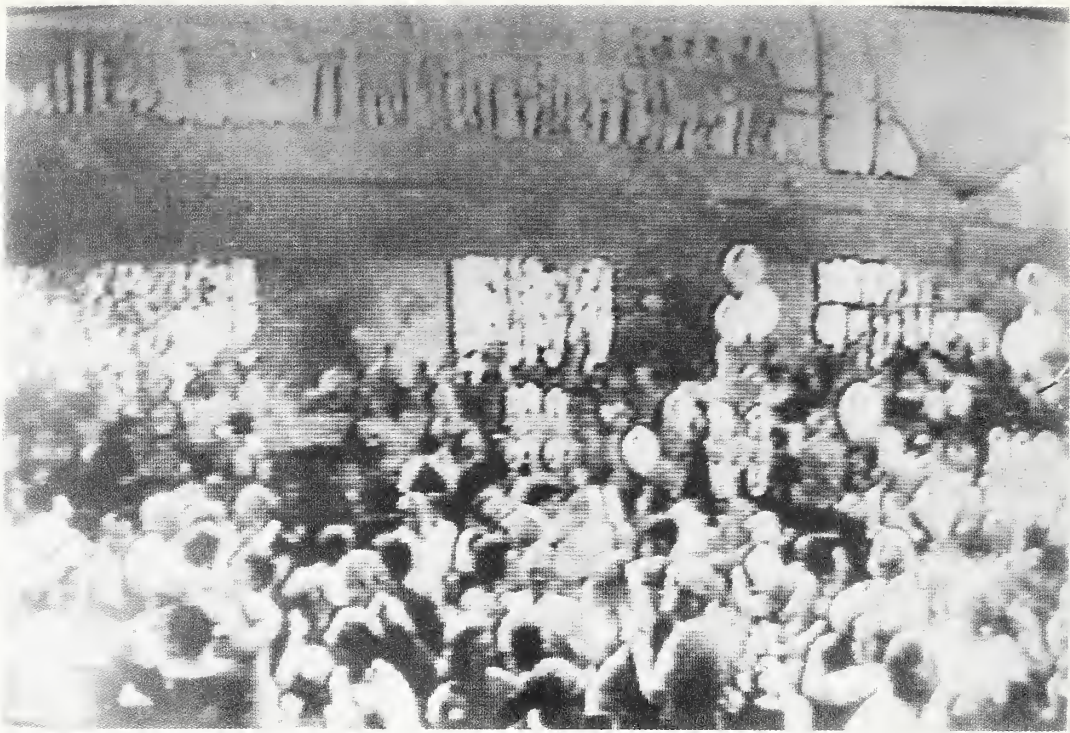
The scene in figure 4.6, taken a few frames later, appears to be from the same location as that in figure 4.5, but shows more of span L8-9. Judging from their relative heights, the people on span L9-10 have not moved from their positions shown in figure 4.5. It appears that the count on span L9-10 is now 11, but blurring makes an accurate count difficult.

Figure 4.6 Same view as figure 4.5, but a few frames later. Videotape courtesy of KMBC TV.

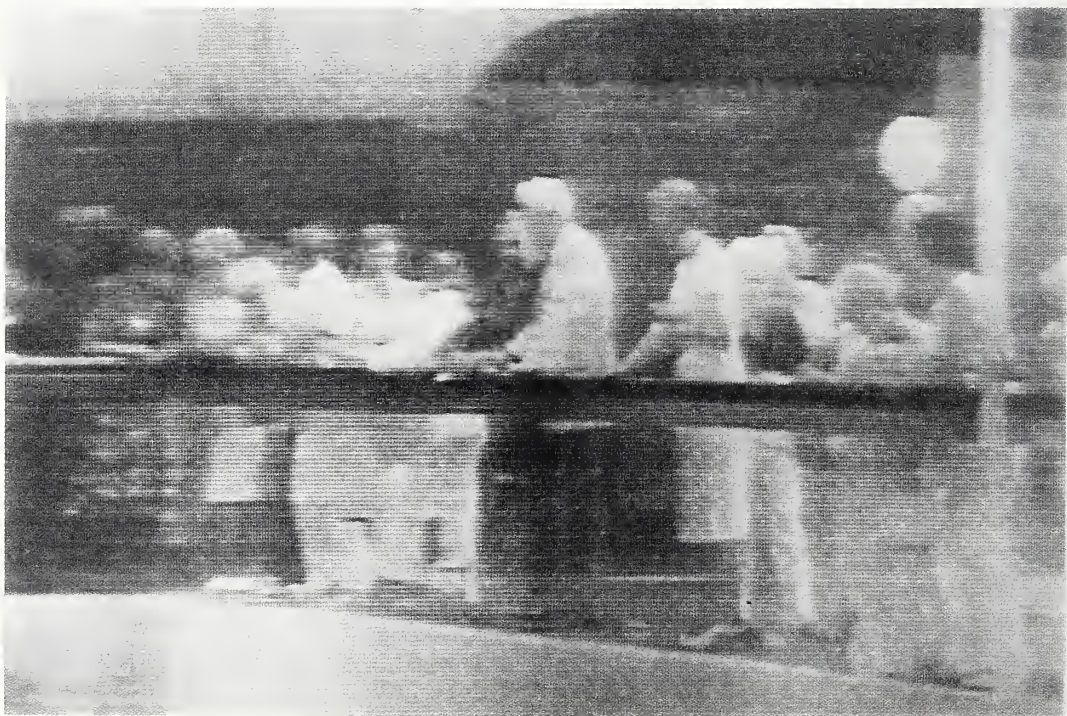
Figure 4.7 is a close-up of the southernmost span (span M7-8) in the third floor walkway. The view is from the same location as figure 4.4. Again, it is difficult to make an accurate count, but at least 11 persons can be observed.

Figure 4.7 View from third floor balcony on north side of atrium. View to southwest showing southernmost span (span M7-8) of third floor walkway. Videotape courtesy of KMBC TV.

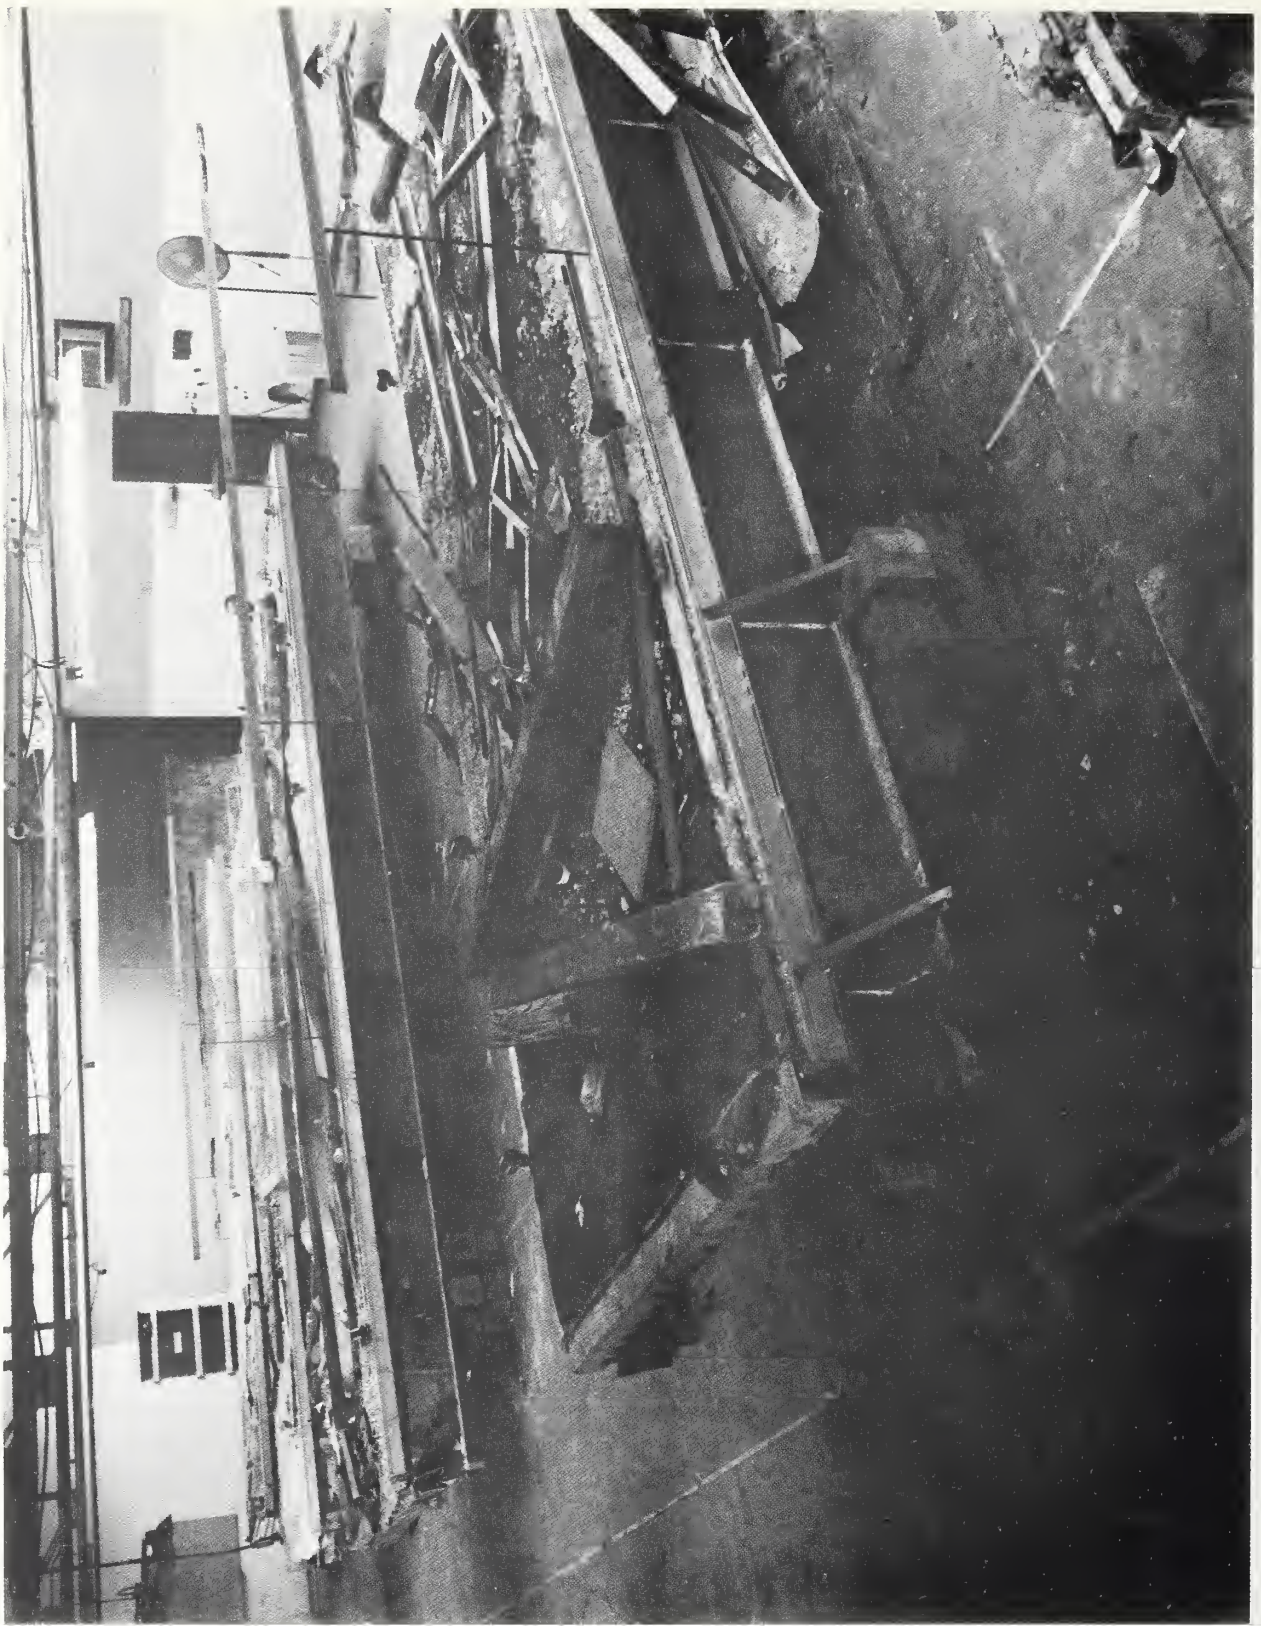
Figure 5.6 General view showing spans of fourth floor walkway.

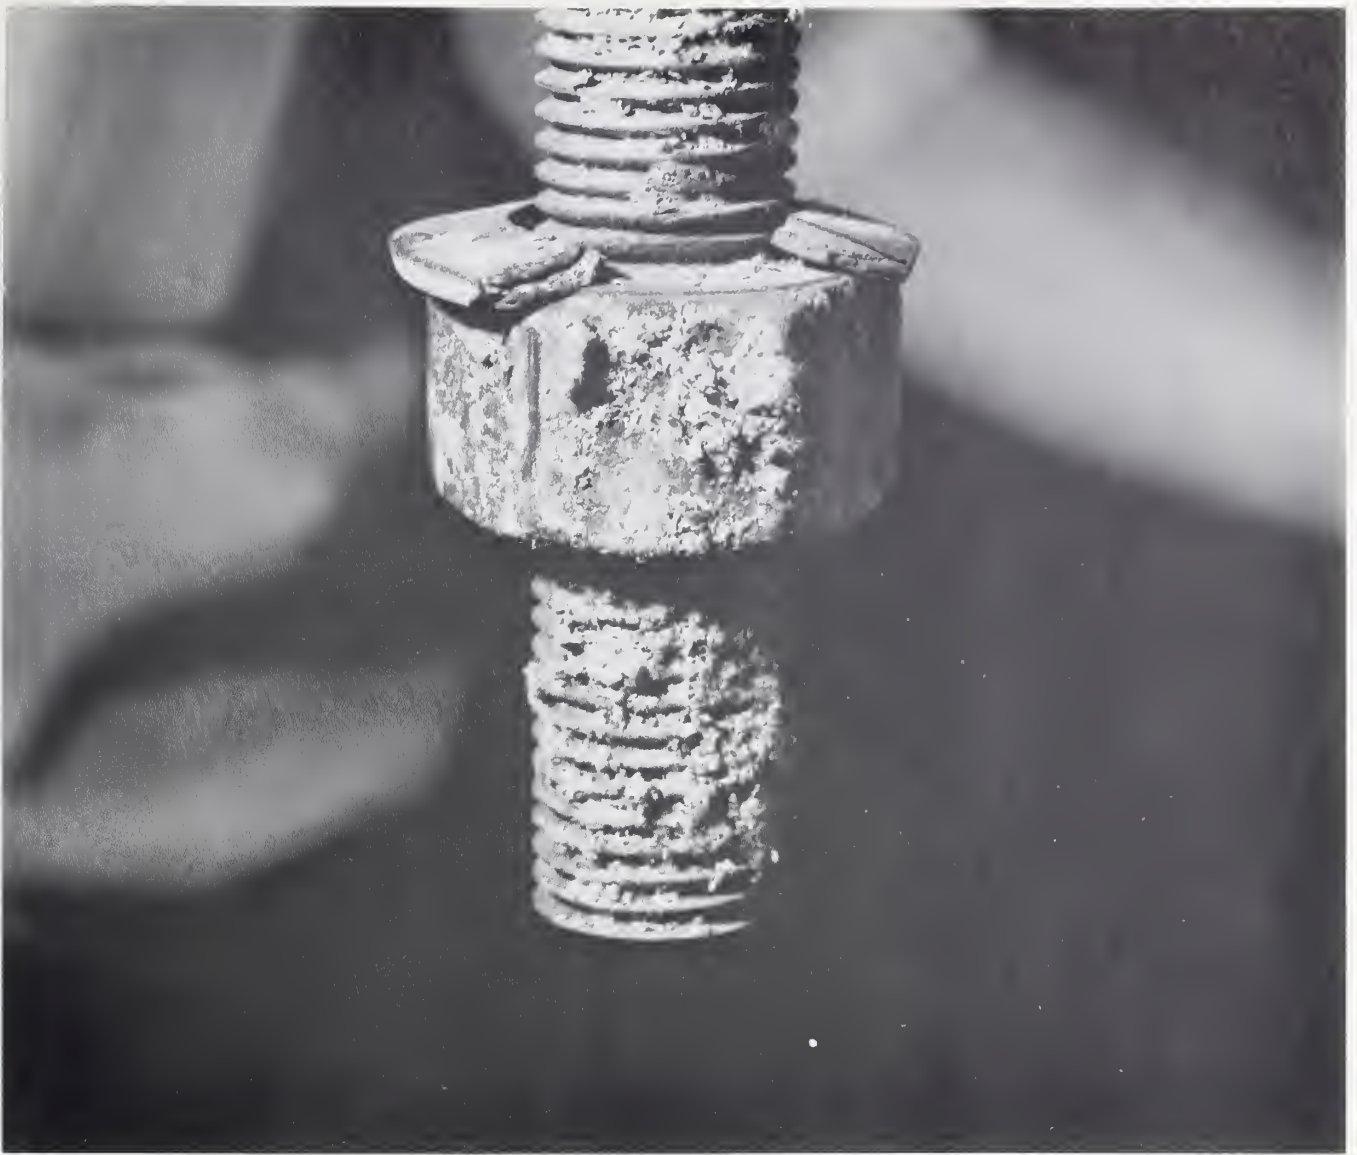
Figure 5.13 Washer at bottom end of fourth floor to ceiling hanger rod 9UW.

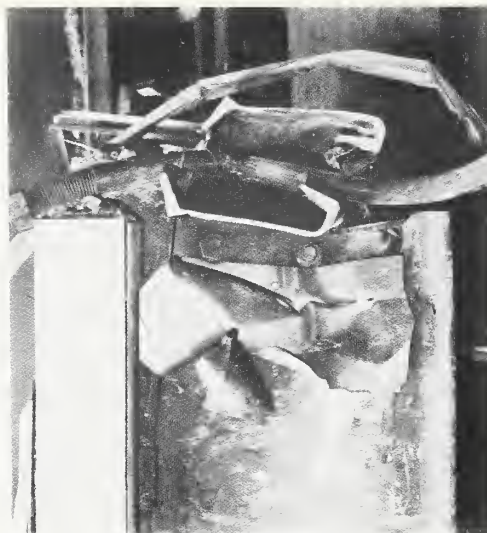
f) Location 10UE.

Figure 5.14 Observed symmetry of distortion of box beams at locations 8U and 10U relative to the box beam at location 9U.

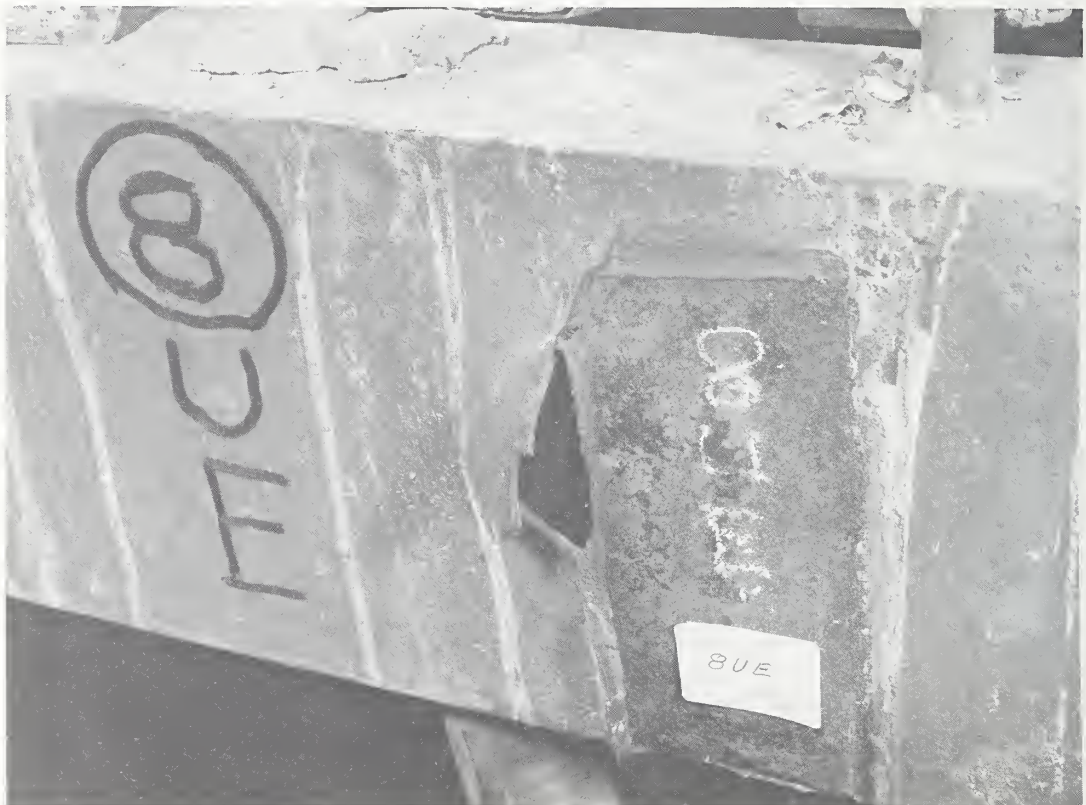
Figure 5.24 Tear in box beam web at location 8UE.

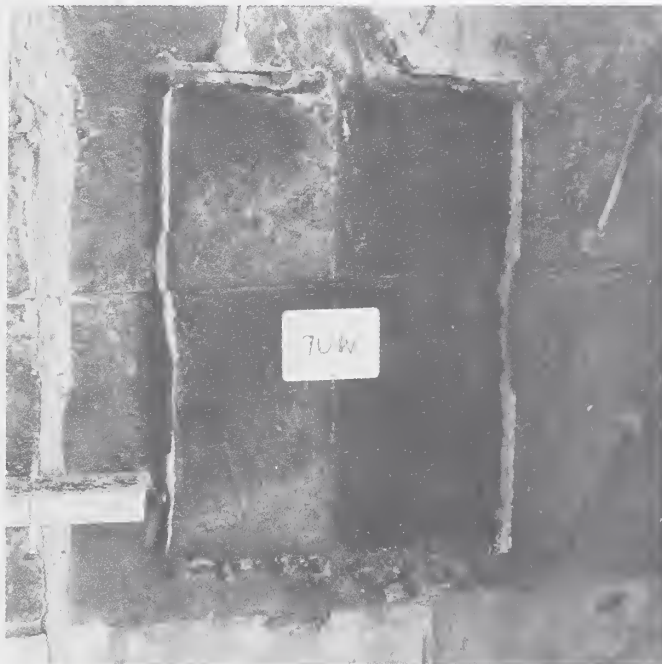
Figure 5.26 Embedded plate at connection 7UW.

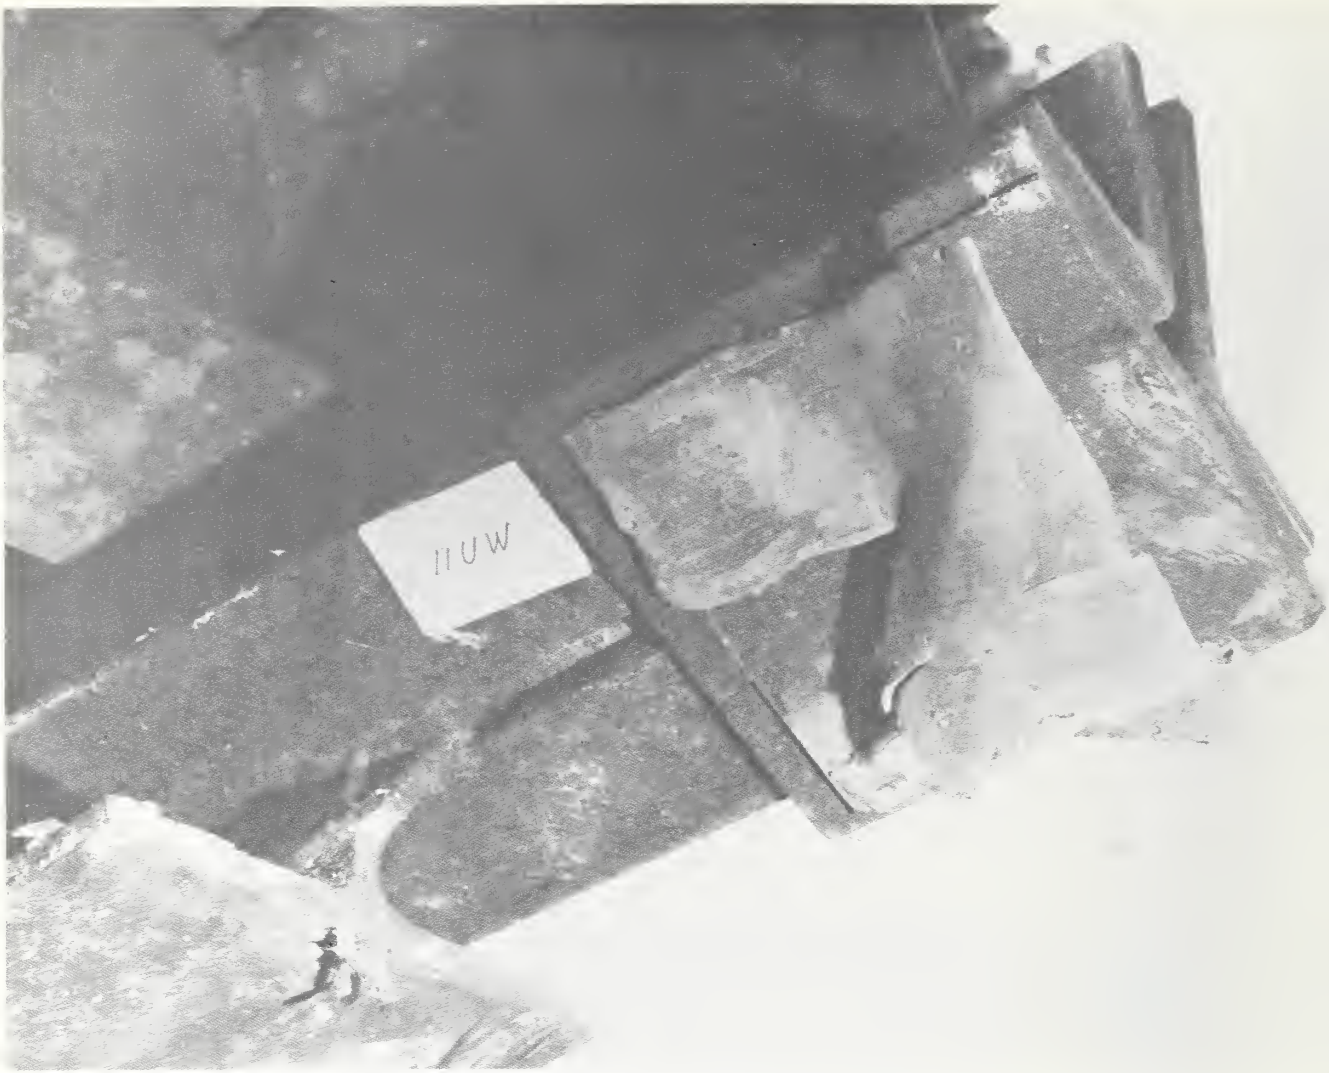
Figure 5.27 Modified bearing pad at location 11UW.

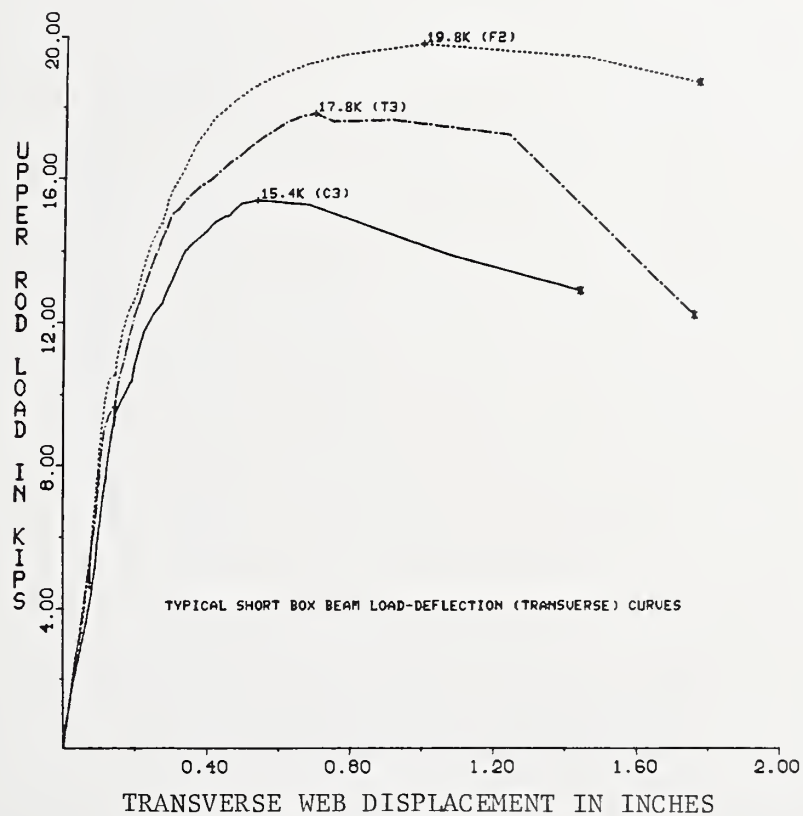
The out-of-plane load-deflection curves show the same trends as exhibited by the in-plane load-deflection curves. The out-of-plane load-deflection curves for the above described specimens are shown in figure 6.16. Each curve is a plot of the same load described for figure 6.15 versus the displacement measured by the middle transverse LVDT (figure 6.13). These data show that the web is beginning to deform outward shortly after the application of dead load from the second floor is started.

Figure 6.16 Out-of-plane web load displacement curves for specimens C-3, F-2, and T-3.

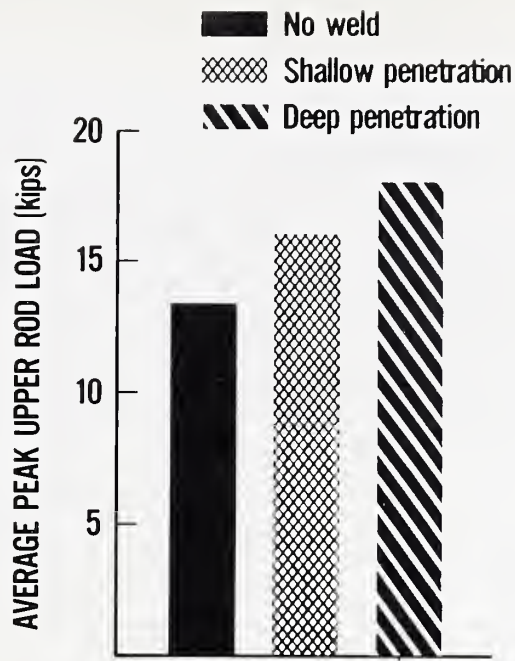
Exterior Weld Penetration. The exterior weld penetration depth for specimens without an interior weld has a significant effect on the peak upper rod load of the short box beams, as shown in figure 6.18. The average peak loads for specimens E1 and E2 having no weld (no penetration), C1 and C3 having a shallow penetration weld, and A1 and A2 having a deep penetration weld are shown in the figure to illustrate that there is significant difference in load resistance between the case of shallow penetration and deep penetration. The difference is about 2.5 kips (11.1 kN).

Figure 6.18 Effect of exterior weld penetration.

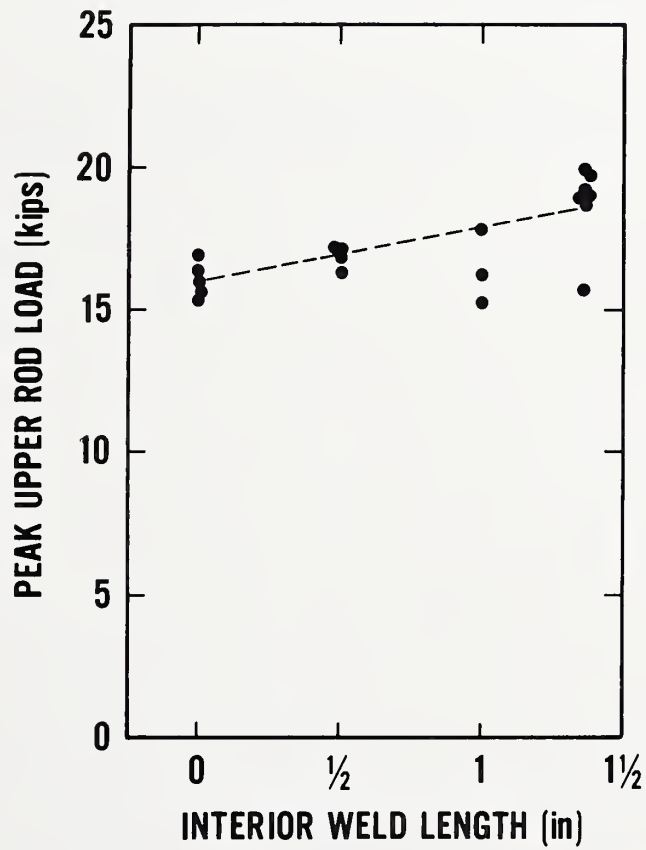
Interior Weld Length. The length of interior weld has a significant effect on load resistance of the short box beams. A limited comparison of test results is shown in figure 6.19 to illustrate this point. Data shown include shallow penetration weld specimens shown in table 6.1 except for variations due to weld position, washer thickness, nut shape, nut orientation, clip angle presence, initial rod load, and number of rods. Although a regression analysis was not done it is apparent that increasing the interior weld length increases the load resistance. The increase in load resistance is roughly linearly proportional to the increase in interior weld length. However length of interior weld alone is insufficient to account for load variation since it does not consider penetration of either the interior or exterior welds.

Figure 6.19 Effect of interior weld length on peak load.

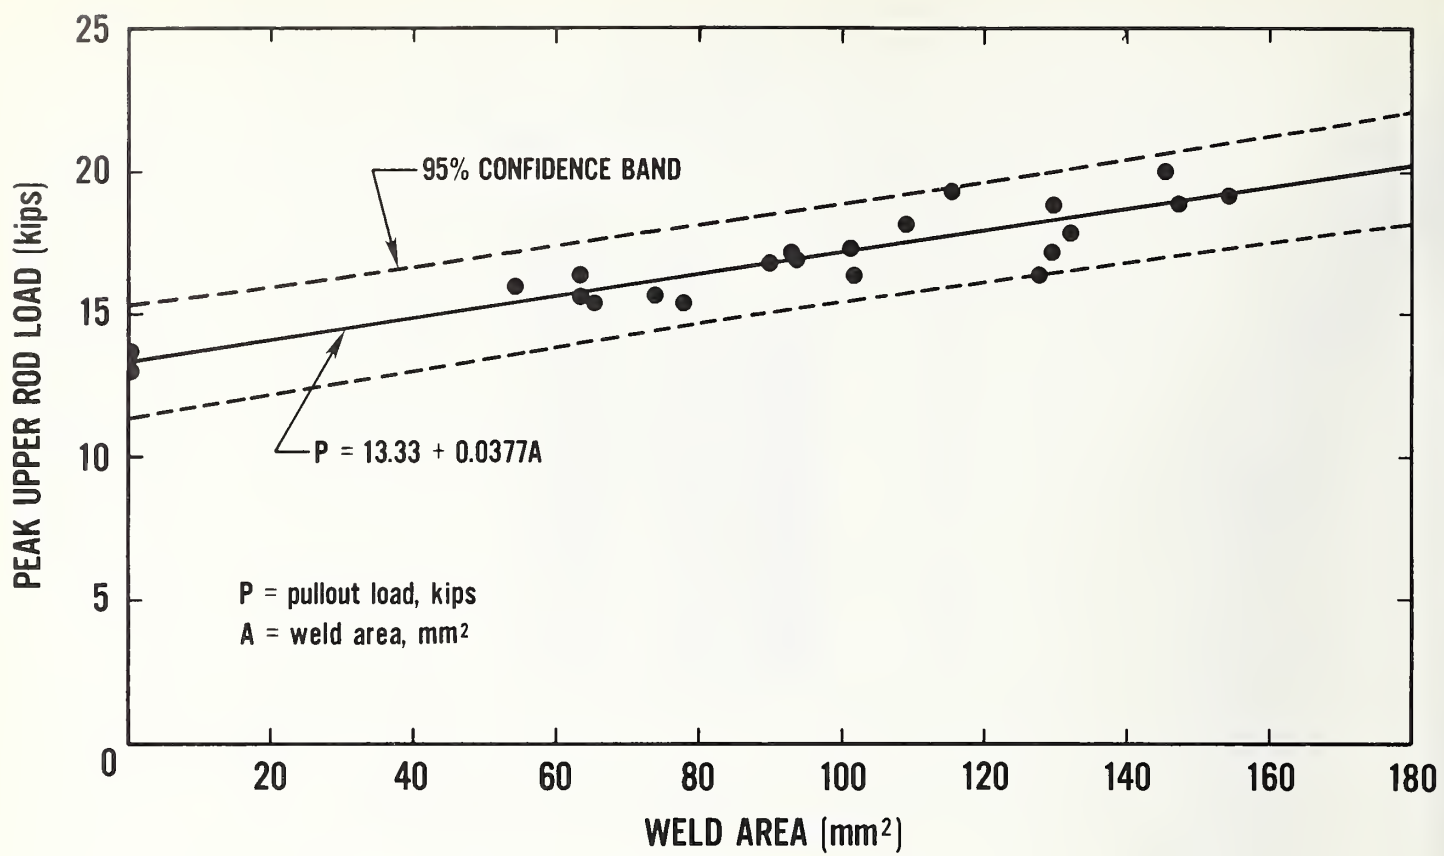
Weld Area. The effect of weld length and depth of penetration of the exterior and interior weld was examined by determining the interior and exterior weld areas between the beam end and the hole for the fourth floor rod. Fracture surfaces between the exterior hole and beam end were examined under magnification for all short box beam specimens. Lengths and depths were measured. Depths were measured at five locations and averaged. These average measurements are summarized in tables 6.1, 6.2, and 6.3, and 6.4 for the NBS tests. Weld area was determined as the sum of the products of the average depth and length for the exterior and interior welds. The peak upper rod load is plotted in figure 6.20 against the weld area. Weld area is used as a measure or index for effectiveness of the weld material to resist load although it is realized that this is a simplification. The trend of the data is as expected; an increase in capacity occurs with the addition of weld metal.

The data shown in figure 6.20 include all tests on short box beams with hardened washers as listed in table 6.1 except for round nut bevel, initial rod load, single rod and clip angle presence. These latter parameters are discussed in section 6.10.5.

Figure 6.20 Effect of weld area on peak load, hardened washers.

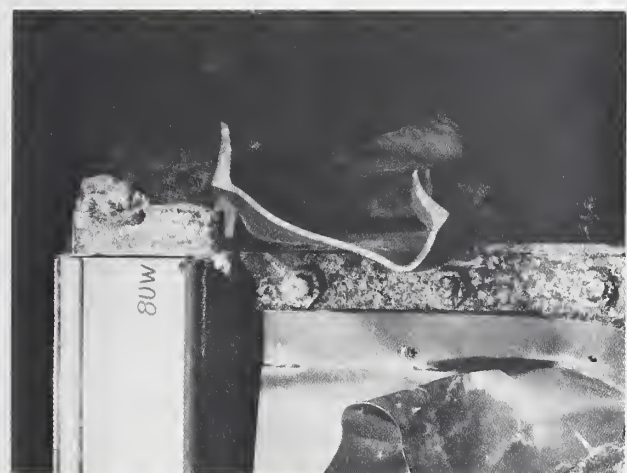
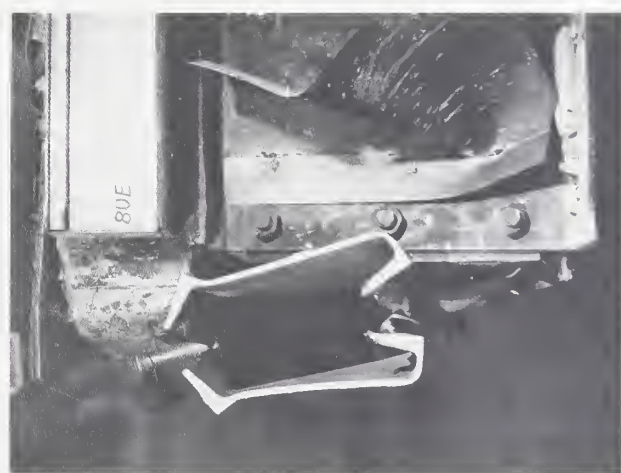
Figure 6.36 Walkway deformed shapes.

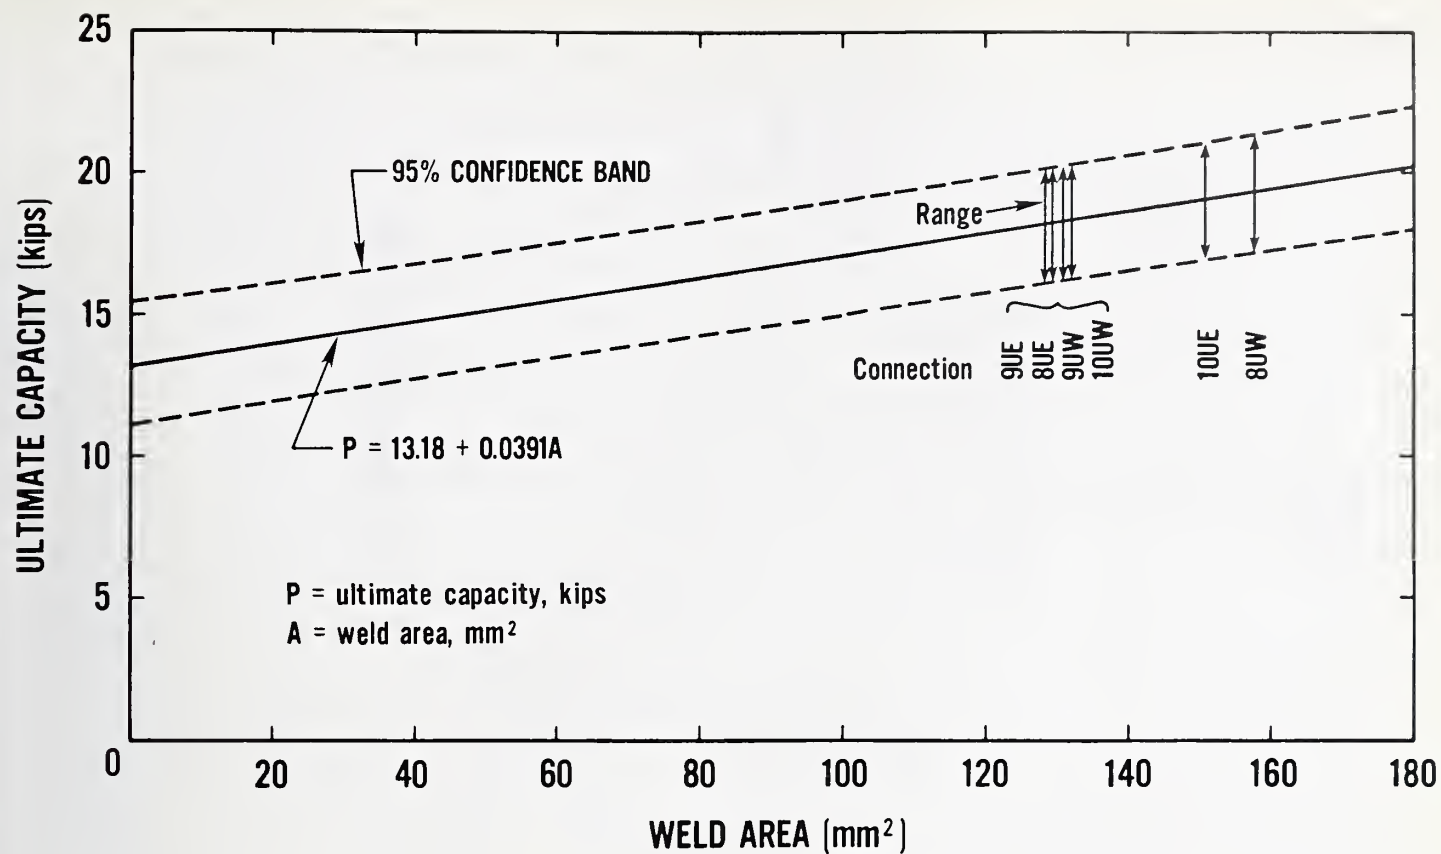
Figure 6.38 Estimated ultimate capacity for walkway box beam-hanger rod connections.

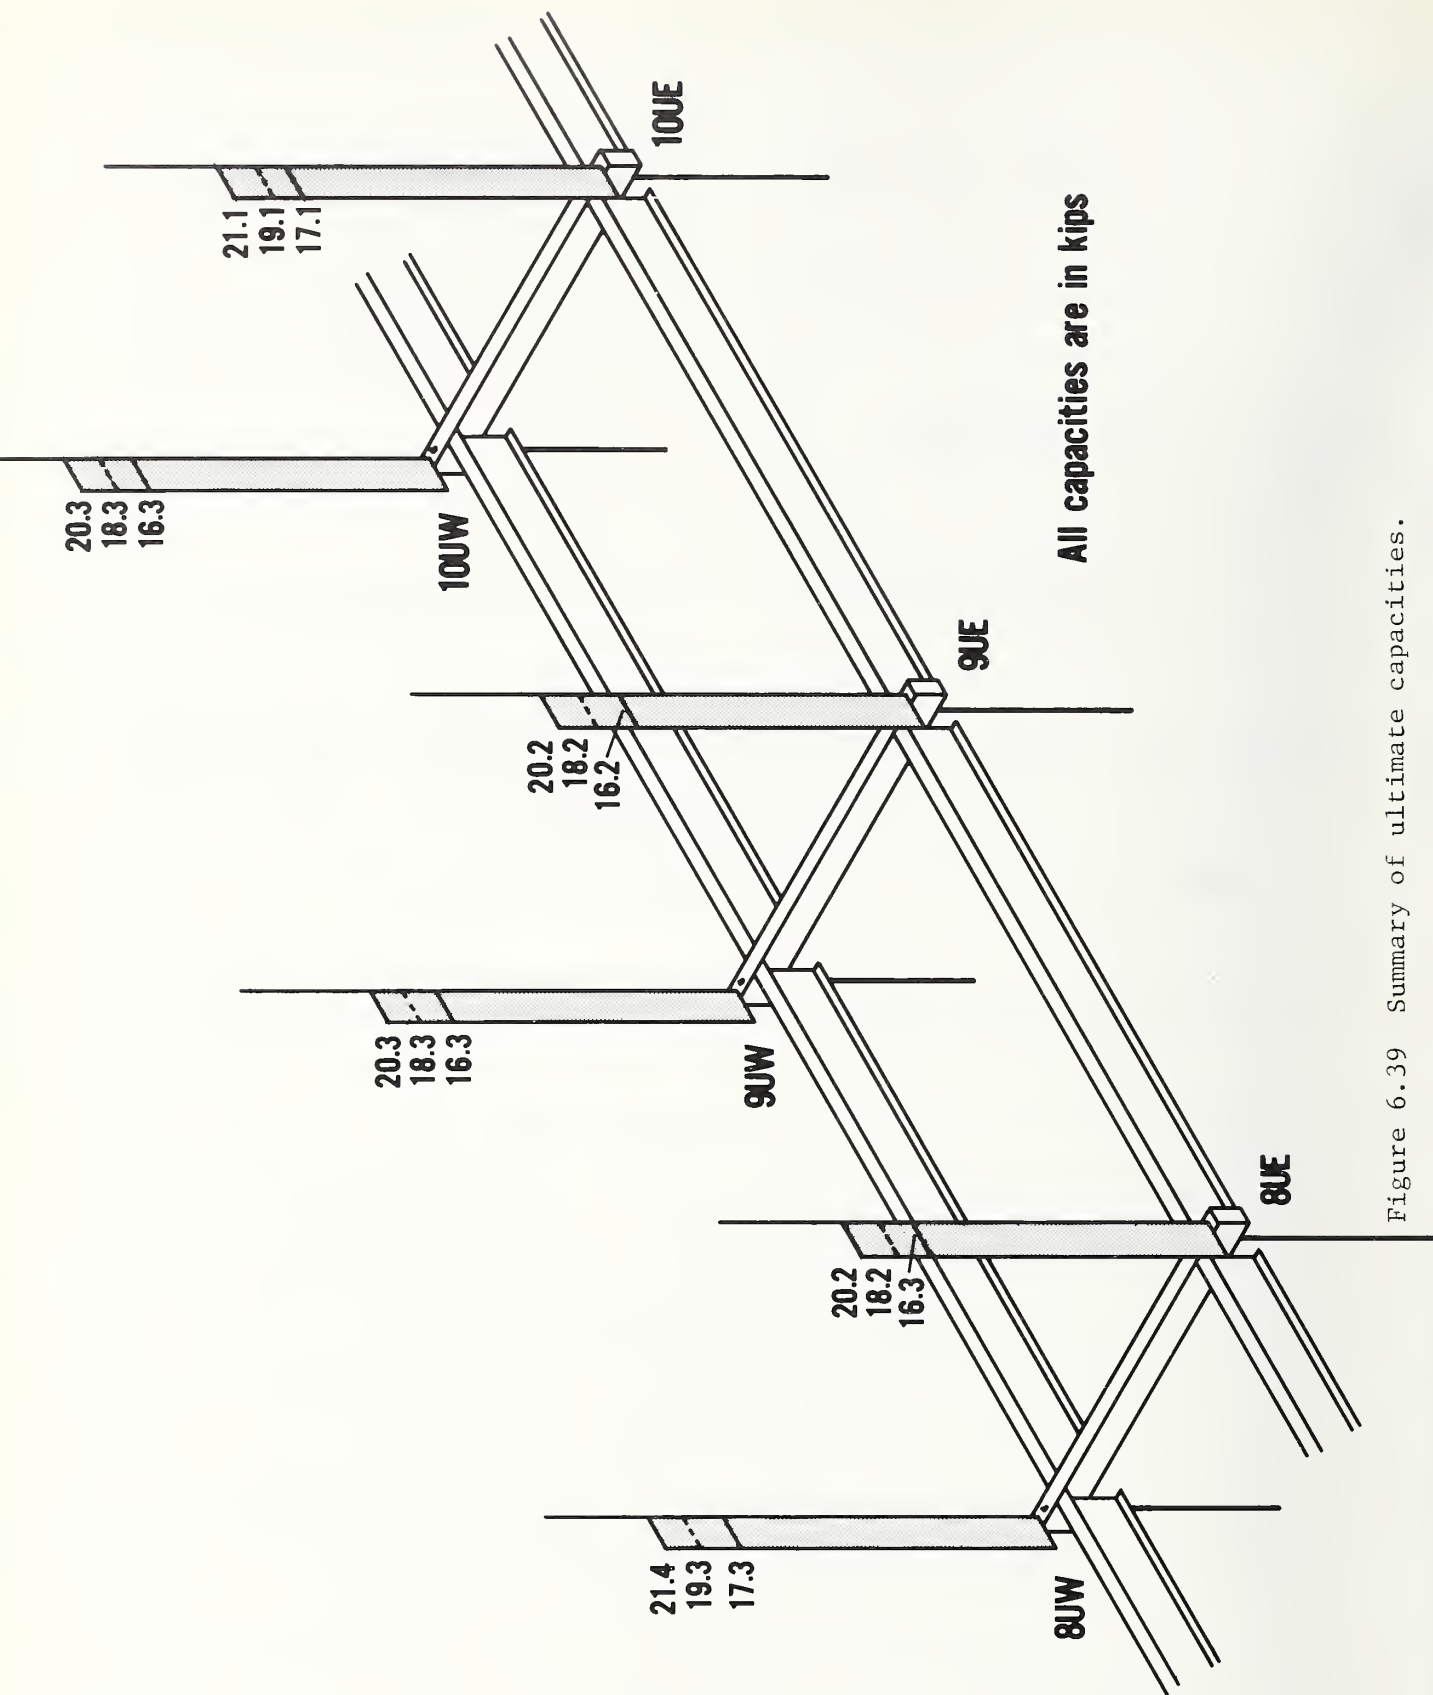
These ultimate capacities are summarized in figure 6.39 on a layout of the six box beam-hanger rod connections. A bar diagram is shown adjacent to each hanger rod. Location 8UE is described to denote the meaning. The range from 16.3 to 20.2 kips (73 to 90 kN) is the 95 percent confidence interval estimate for this particular box beam-hanger rod connection. The mean ultimate capacity of 18.2 kips (81 kN) is also shown. The mean capacity for all connections is 18.6 kips (83 kN).

Figure 6.39 Summary of ultimate capacities.

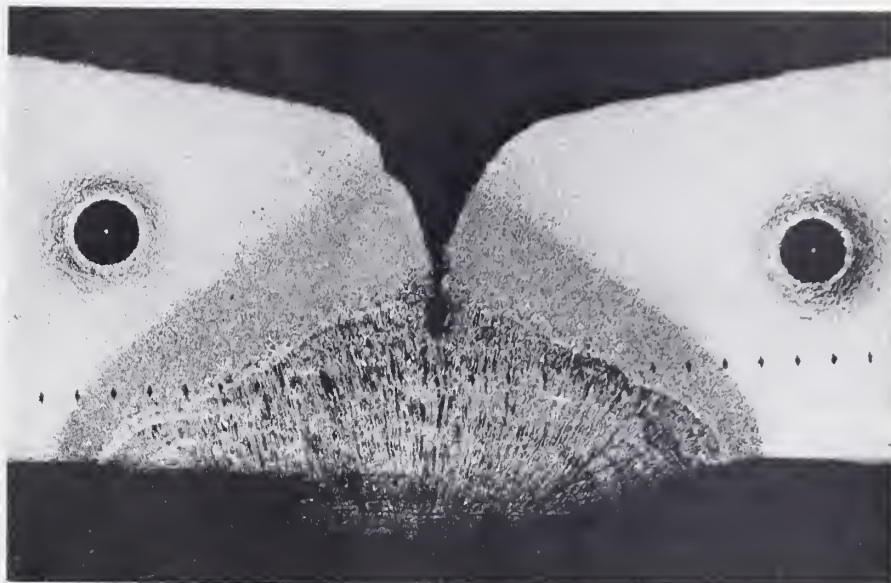
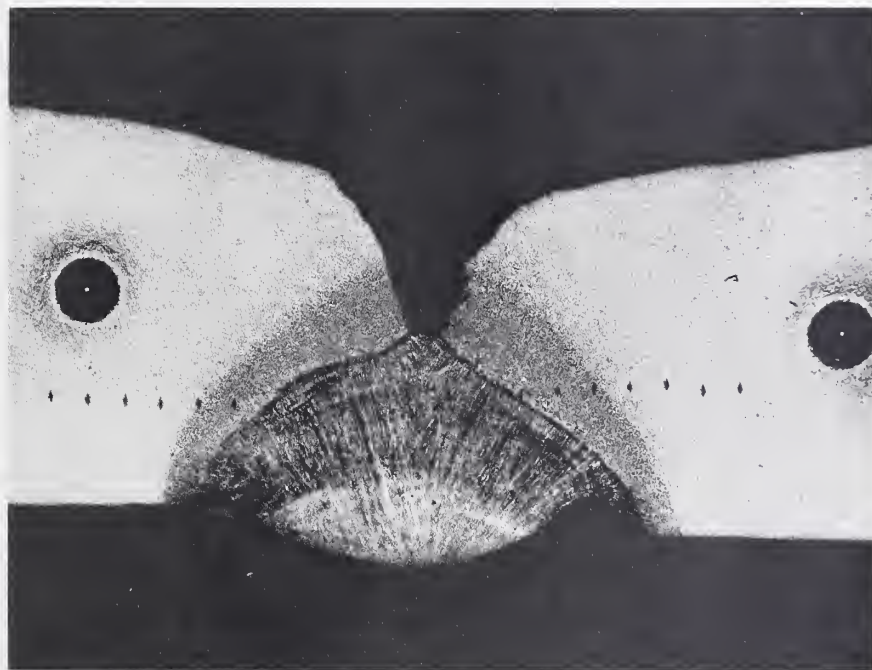
Figure 7.10 illustrates the appearance of an NBS weldment made by the GMAW process, while figures 7.11-7.13 illustrate the appearance of weld regions in box beams 9U, 8L and 9M, respectively. Basic walkway weldment hardnesses were normal. Maximum hardnesses were 92-95 Rockwell B (HRB) for the weld regions, 85-93 HRB for the heat-affected zones and 70-79 HRB for the unaffected parent metal. Small zones of increased hardness (28-33 HRC) were noted in the heat-affected zones of one section taken from location 9U and one section taken from location 8L. The structure of the hard zones appeared to be tempered martensite.

Figures 7.10 to 7.13 illustrate a substantial variability in the contour of the mating flange ends forming the faying surfaces for welding. The effect, coupled with differences in weld penetration, creates regions of varying notch acuity in the weld region. However, no cracks were observed to have initiated from such notches in any of the sections studied.

Figure 7.12 Cross sections through weld regions of box beam 8L. Sections were separated about 7.5 in (190 mm) along the beam length. Microhardness indentations traverse the surfaces. X8 1/2

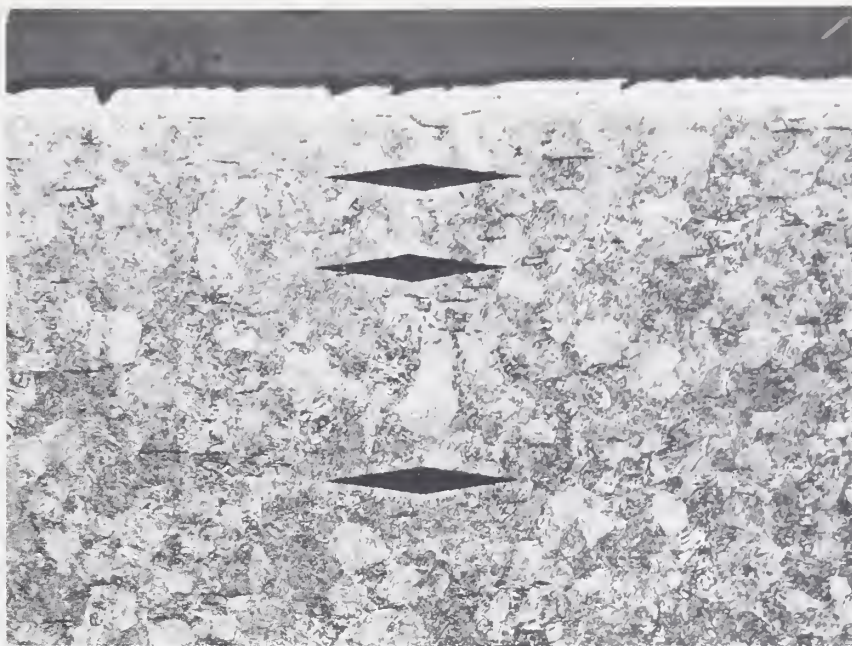
Photomicrographs of the fractured washer (9MW) and of the NBS hardened washer in figure 7.16 show a tempered martensite interior and a thin decarburized layer on the surface. This is typical for hardened washers.

Figure 7.16 Microstructures of washers from 9MW (NBS specimen 3), (a), and of hardened washer used in NBS tests, (b). Whiter layer near surface (top of illustrations) is decarburized layer. Interior structure is tempered martensite. Etchant: Picral. X200

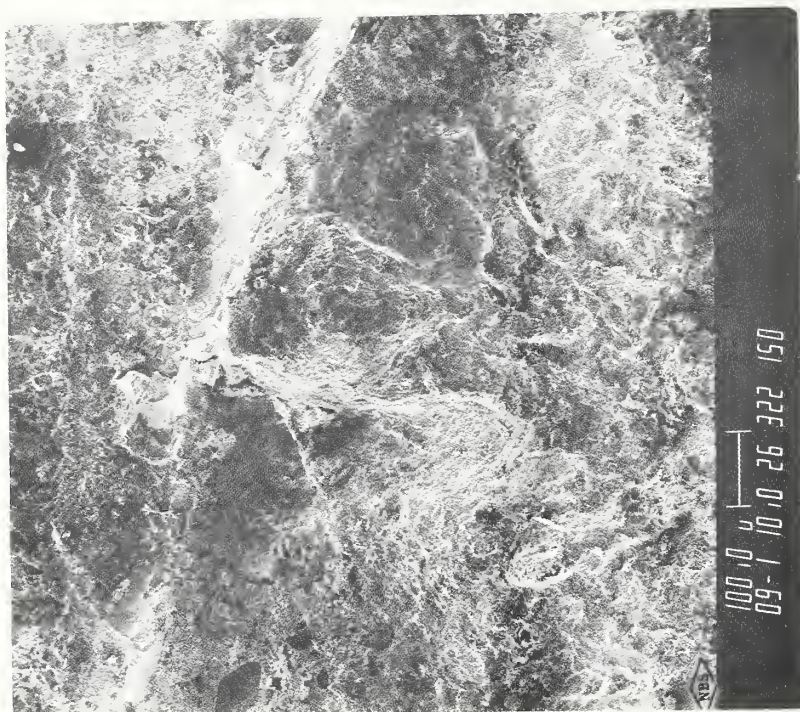
Procedures used to replicate the fracture surfaces have been described in section 5.5. The replication technique is capable of reproducing details of the fracture surface with reasonable fidelity, provided that intimate contact is achieved between the replication media and the surface (figure 8.1). Failure to achieve contact produces artifacts in the replica that must be discounted in the analysis. The replica is a mirror image of the original surface and may have a different sense of image contrast--in one case the image contrast is due to both topography and composition variation (8.1a) and in the other the image contrast is due to topography alone (8.1b). Selection of a specific replica from each surface for study was based on visual evaluation of the

Figure 8.1 Comparison of quality of image by direct SEM (a) and by replication (b) where replica contact is ideal. Fracture surface is located at root of upper exterior longitudinal weld of walkway box beam at location 8UW (north). Magnification X100.

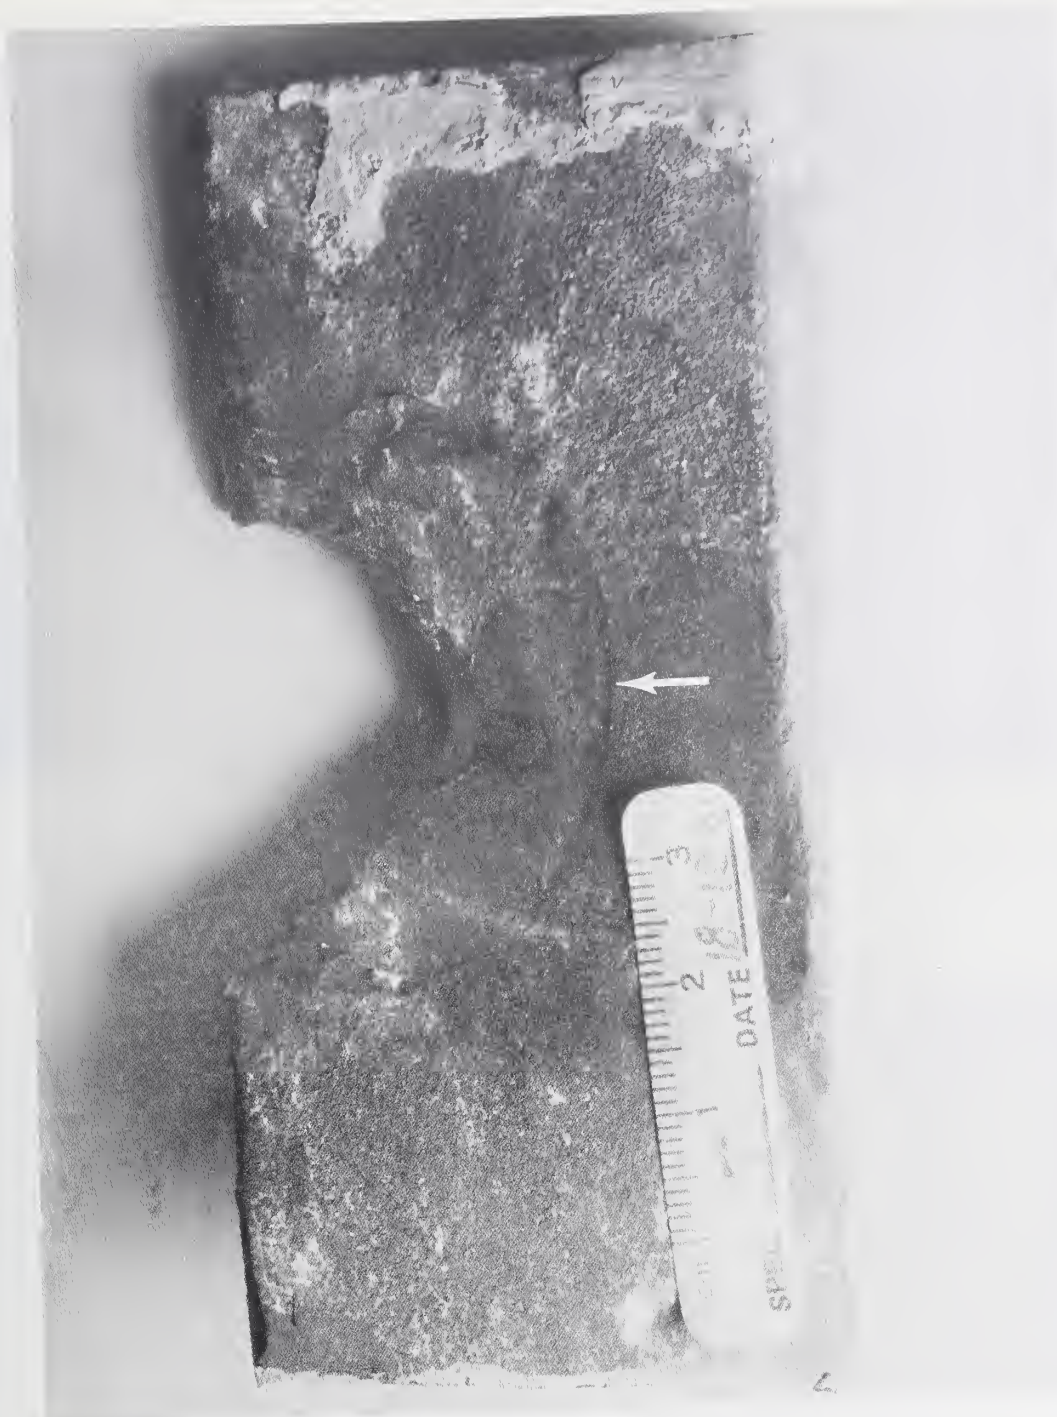
Figure 8.10 Washer contact region on bottom flange at location SUE (north).
Arrow denotes initial washer position. Magnification X1.5.
